Manhole Inspection Summary

Manhole # S15E1_009MH

Location Address: **2960 parkman av**

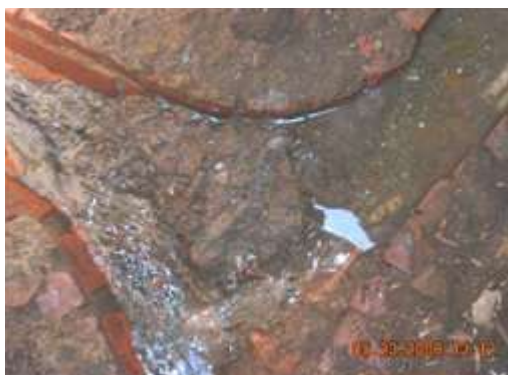
Defect 3

Condition: ☐ Sound ☐ Cracked ☐ Root Intrusion ☐ Deteriorated ☐ Leaks ☒ **Debris**

debris in channel

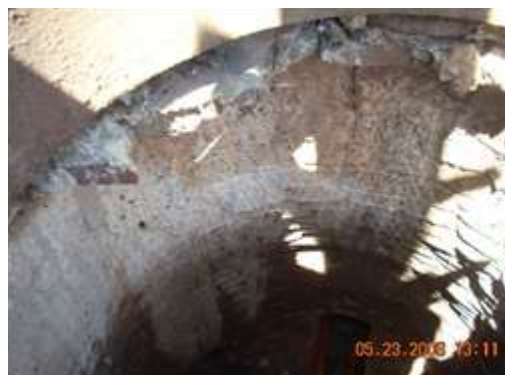
Defect 2

Infiltration: ☐ None ☒ **Joint** ☐ Cracks ☐ Mortar ☐ Roots ☐ Wall

infiltration @ chimney/frame joint

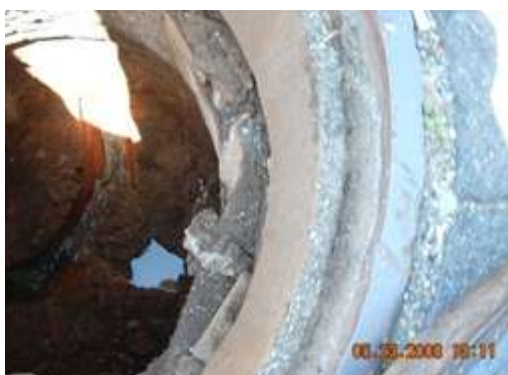
Defect 1

Frame Offset: **1.5** (in.) Condition: ☒ Sound ☐ Cracked ☐ Leaks

frame offset

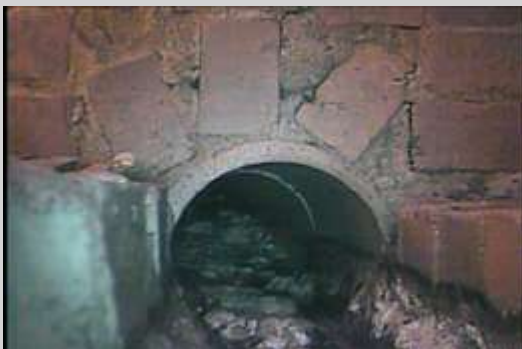
3 O'Clock Inflow

Pipe Height: **6** (in.) Rod and Bar (Angled)
Pipe Material: **Clay** ☐ Pipe Lined
Invert Depth: **7.35** (ft.) Flow Characteristics: **Slow**
Deposits: ☐ None ☐ Mud ☒ Sludge ☐ Debris ☒ Grease
Silt Depth: **3** (in.) Deposits Extent: **Heavy**
Infiltration: **None** Pipe Seal Cond: **Sound**

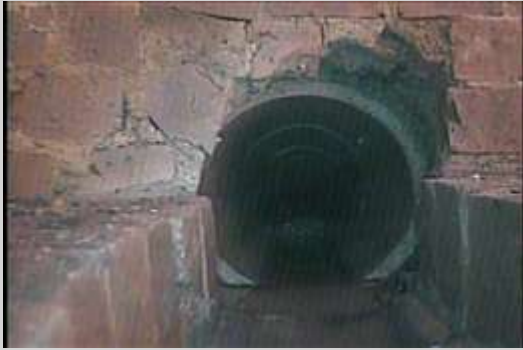
9 O'Clock Inflow

Infiltration: **None** Pipe Seal Cond: **Broken**
